## **Arkema Facility - Harvey Response**

Arkema Inc.

September 7, 2017

Project #109489 Summary

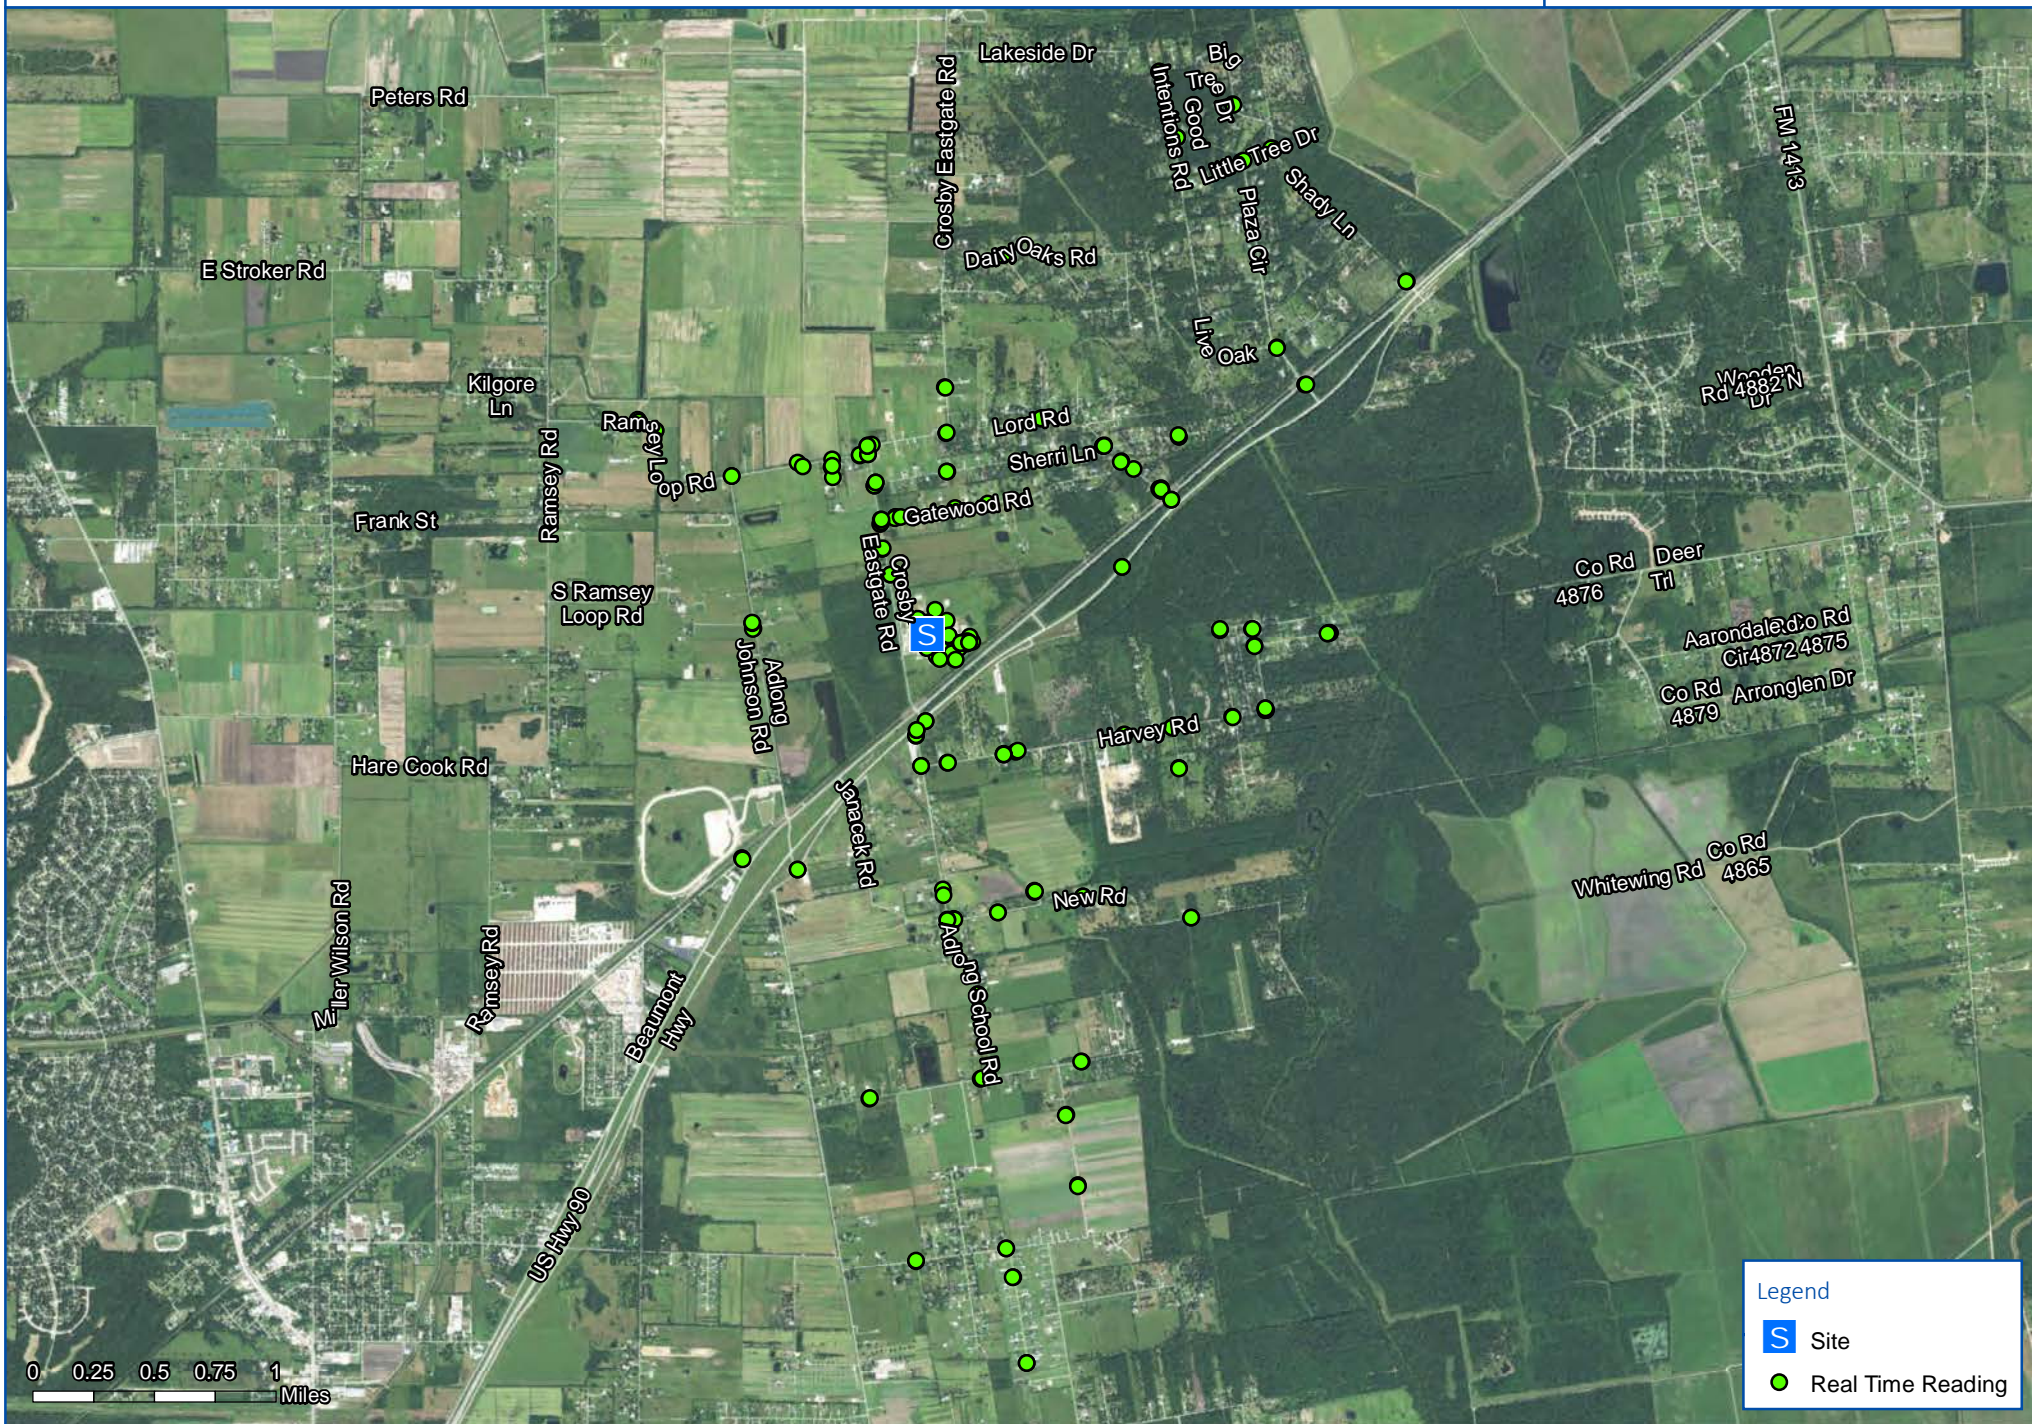
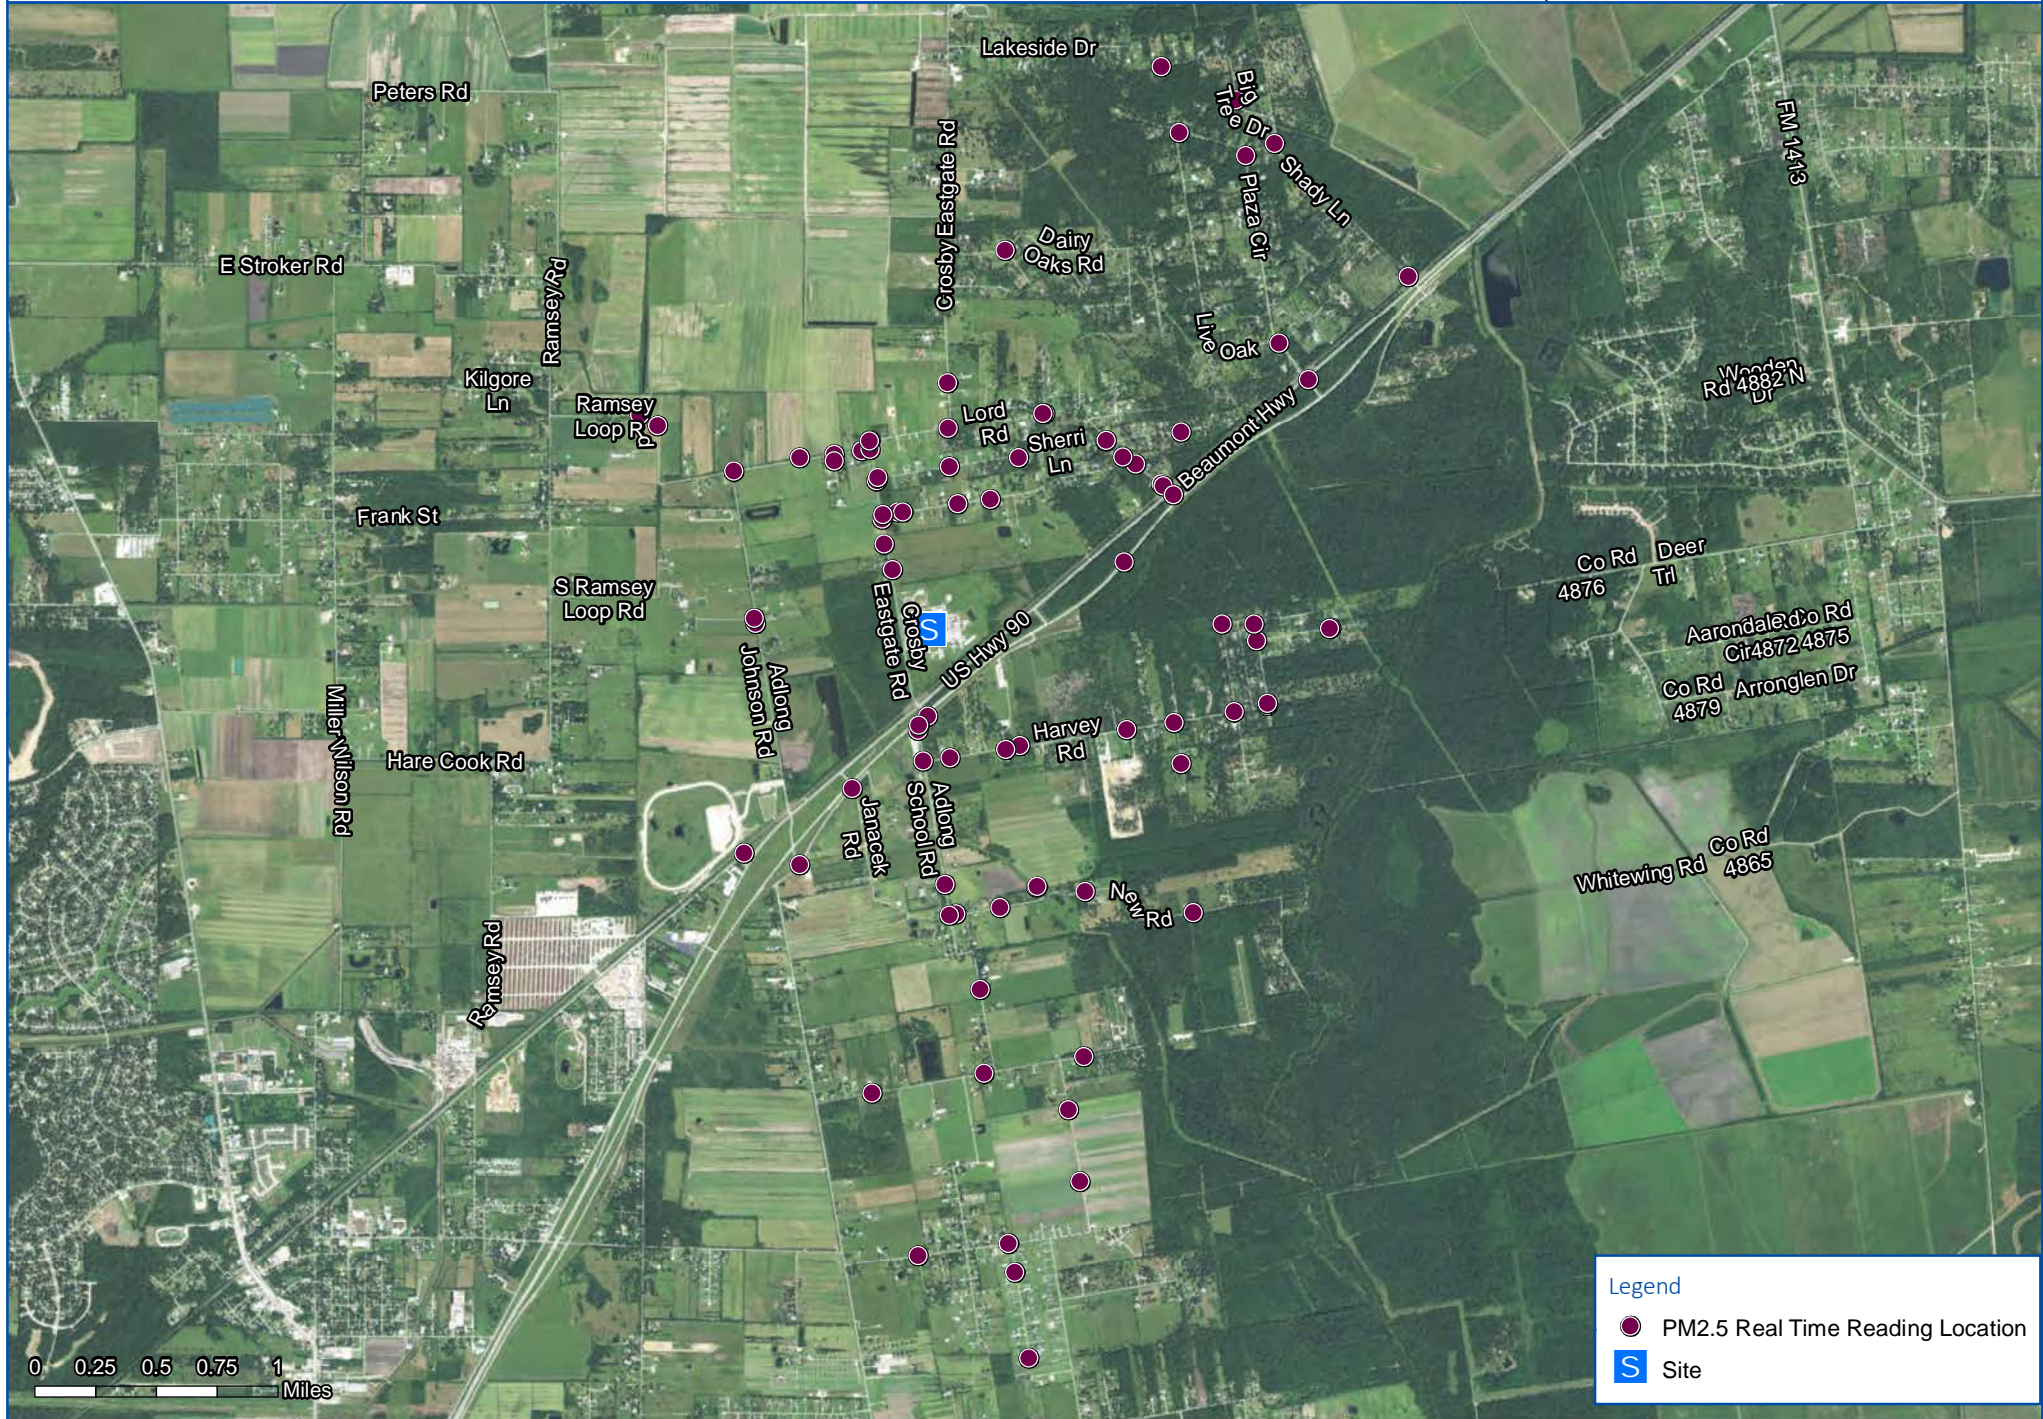
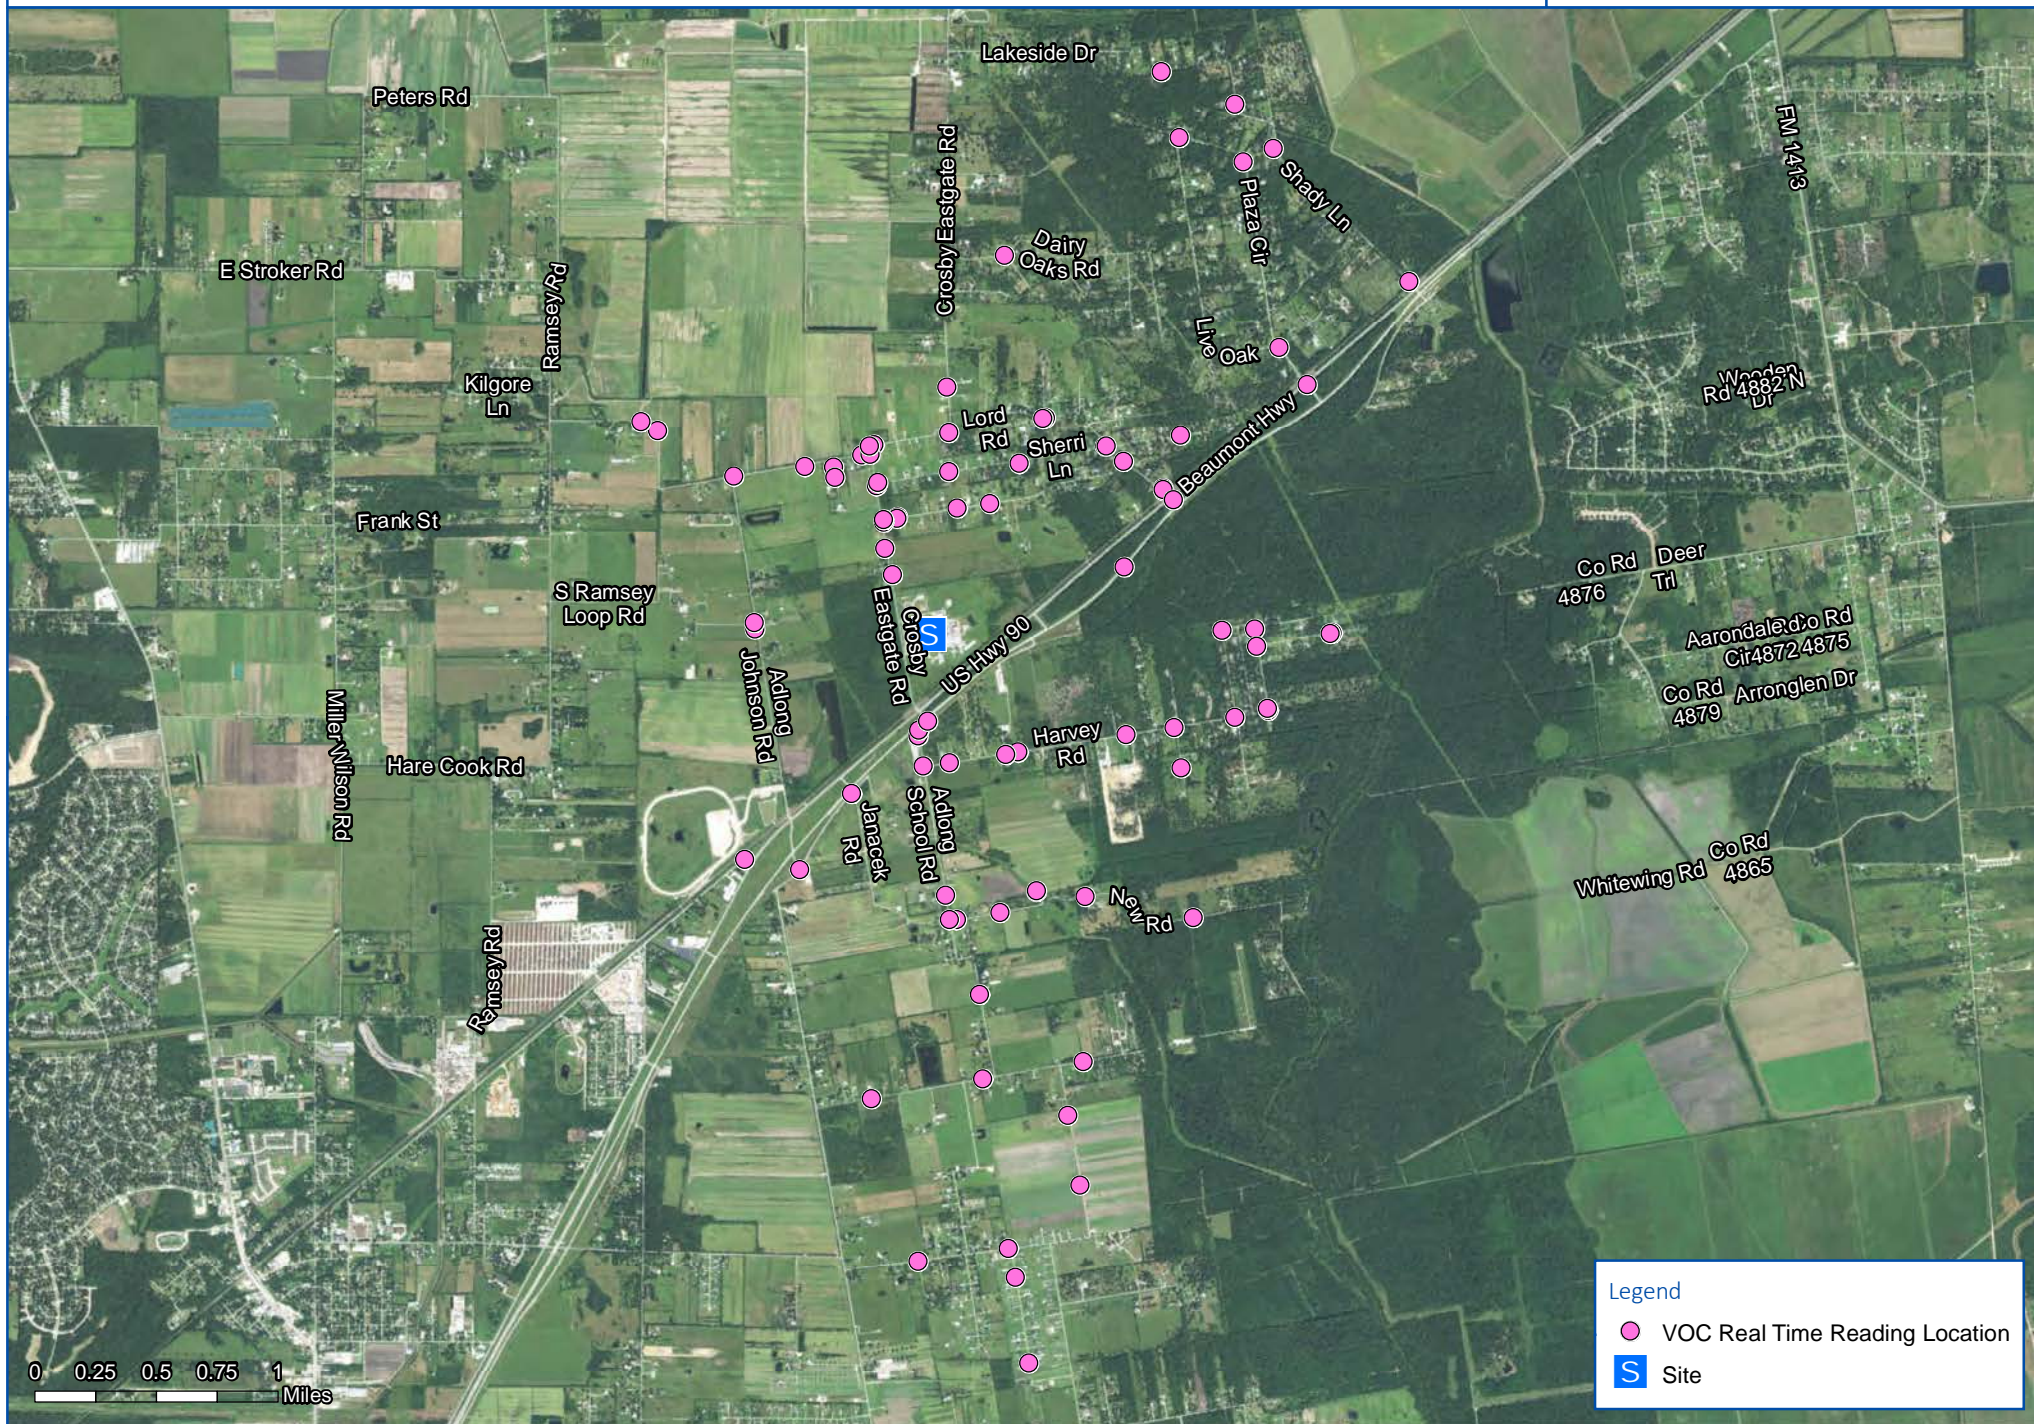
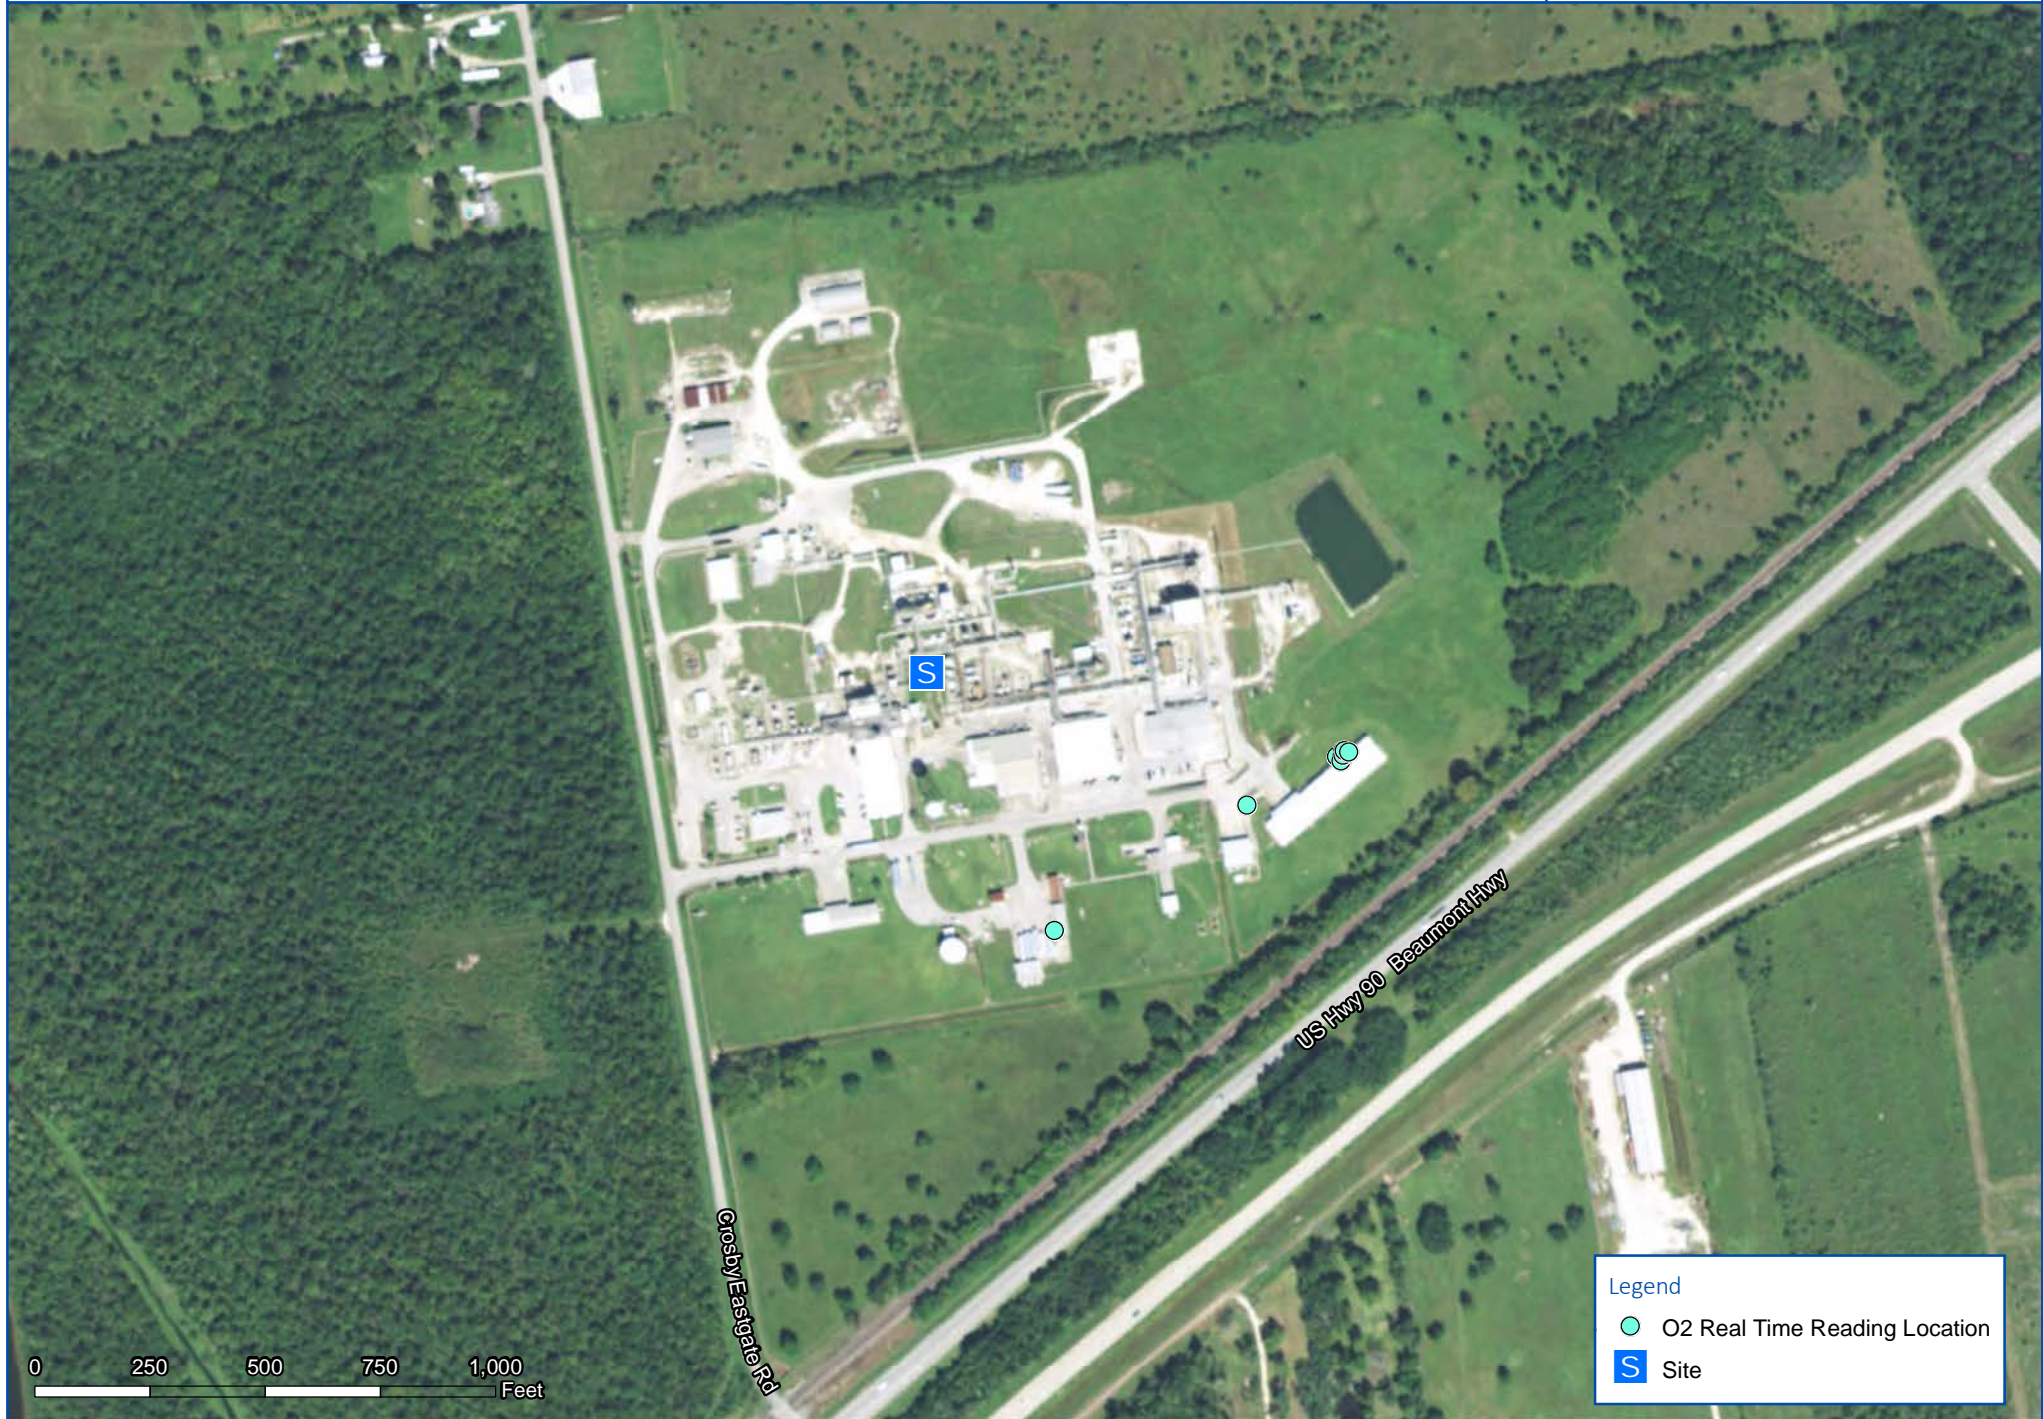
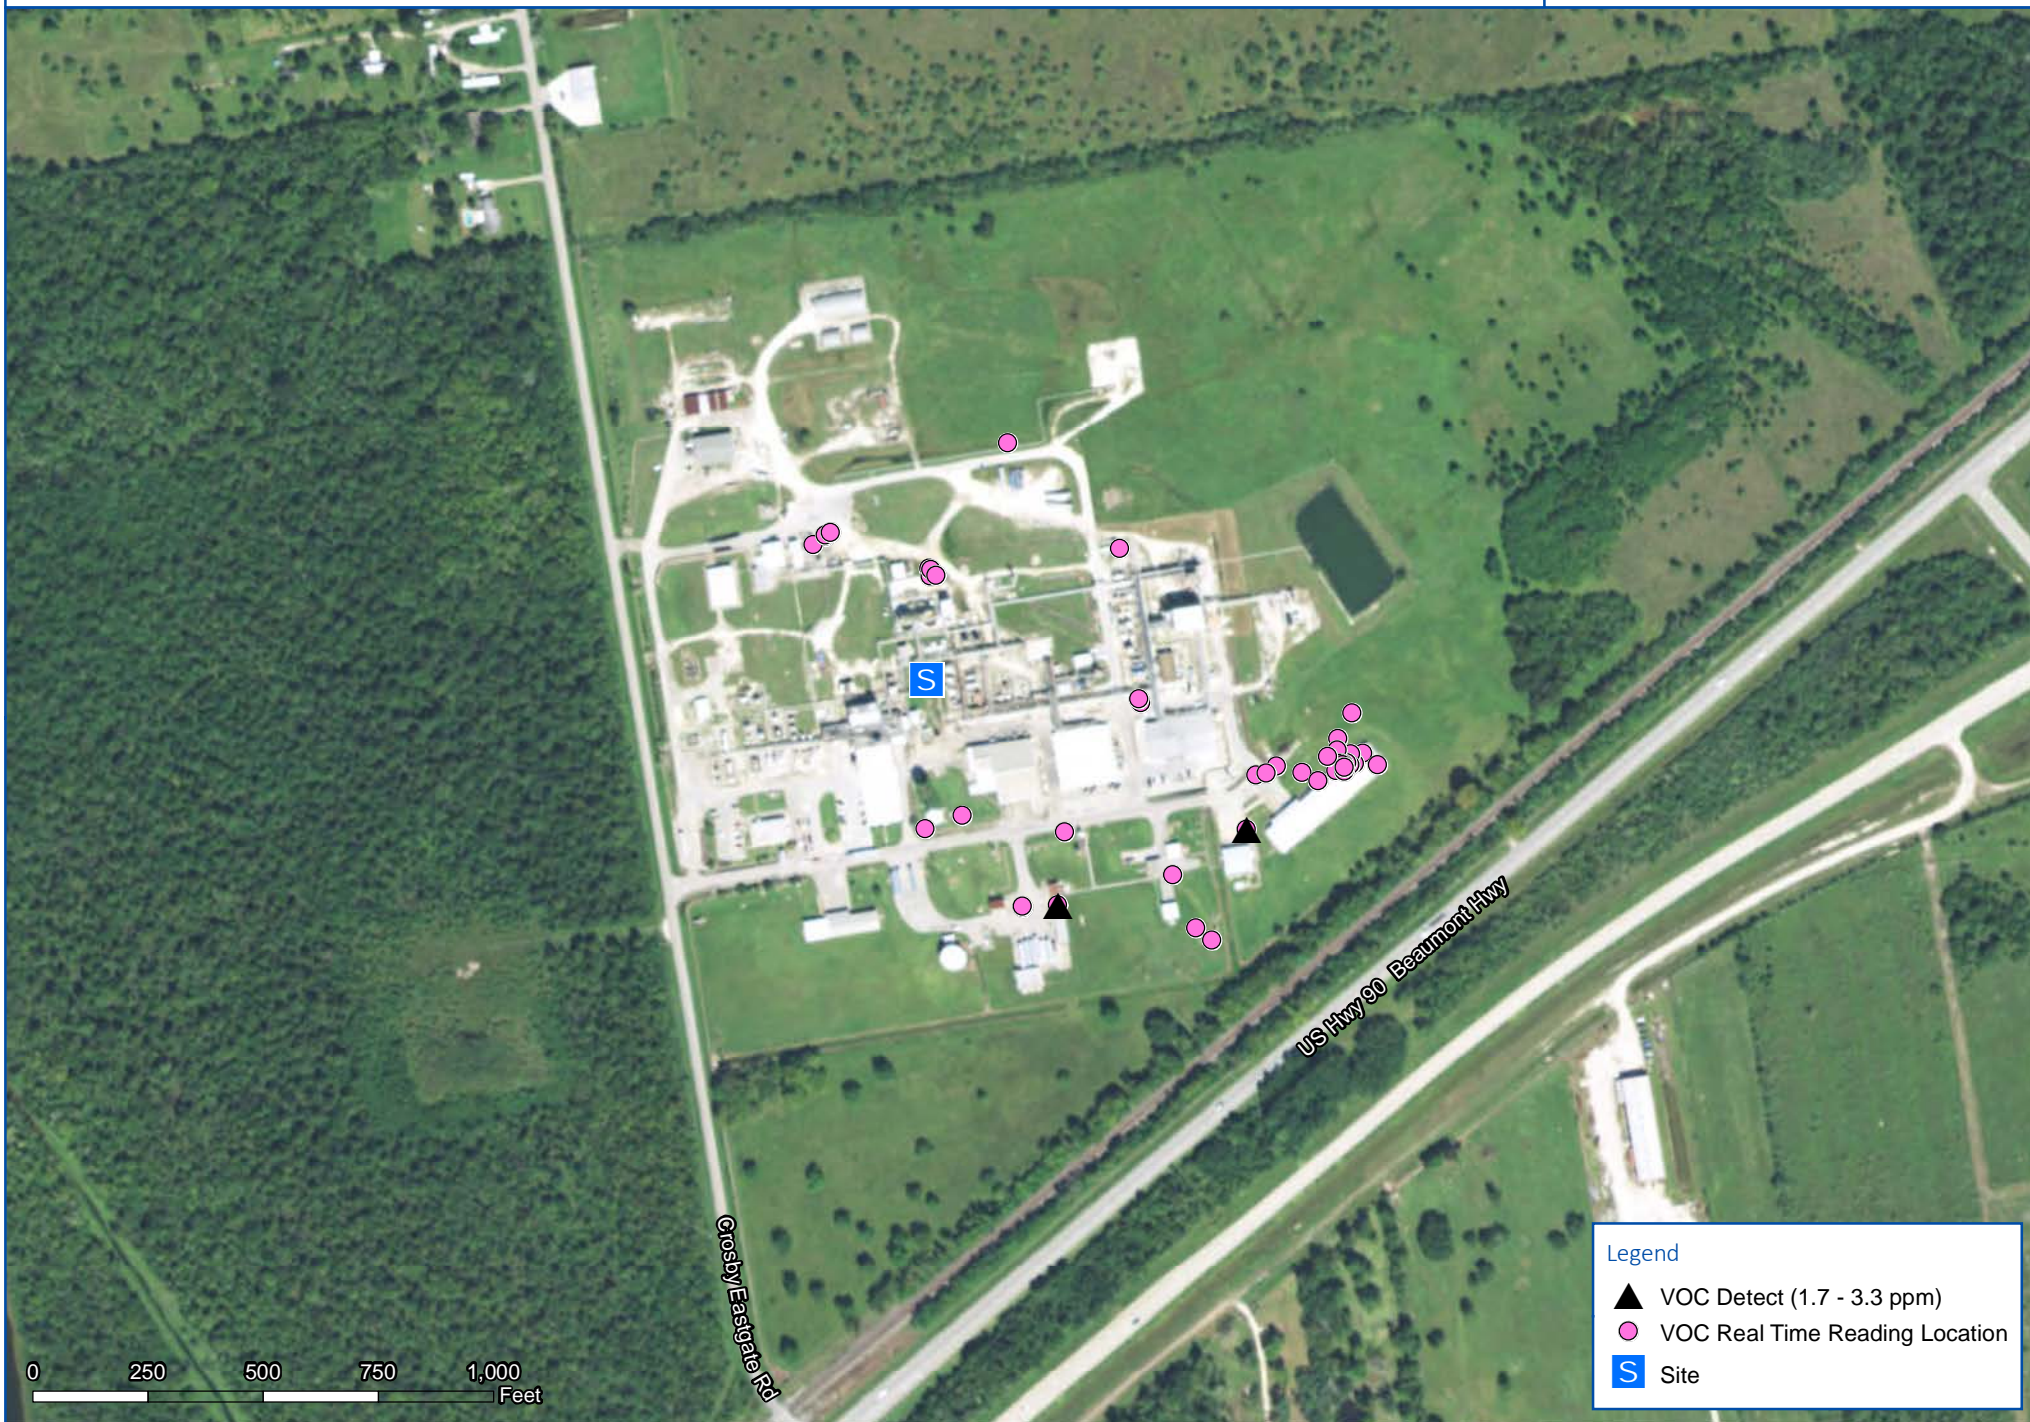
## **Handheld Real-time Air Monitoring Locations**

All real-time air monitoring instrumentation was calibrated per the manufacturer's recommendations prior to air monitoring. Handheld, real-time air monitoring was conducted for oxygen (O<sub>2</sub>) and volatile organic compounds (VOCs) using RAE Systems MultiRAE instruments. Additionally, particulate matter (PM<sub>2.5</sub>) was assessed using TSI SidePak AM510s. **Table 1** summarizes the data for all real-time air monitoring readings recorded in the Crosby, TX Community from 06:00 on September 6, 2017 through 06:00 on September 7, 2017 and Table 2 summarizes the Worker Activity real-time air monitoring readings from within the site boundary for the same period. Maps of real-time air monitoring locations are provided as **Attachment B**.

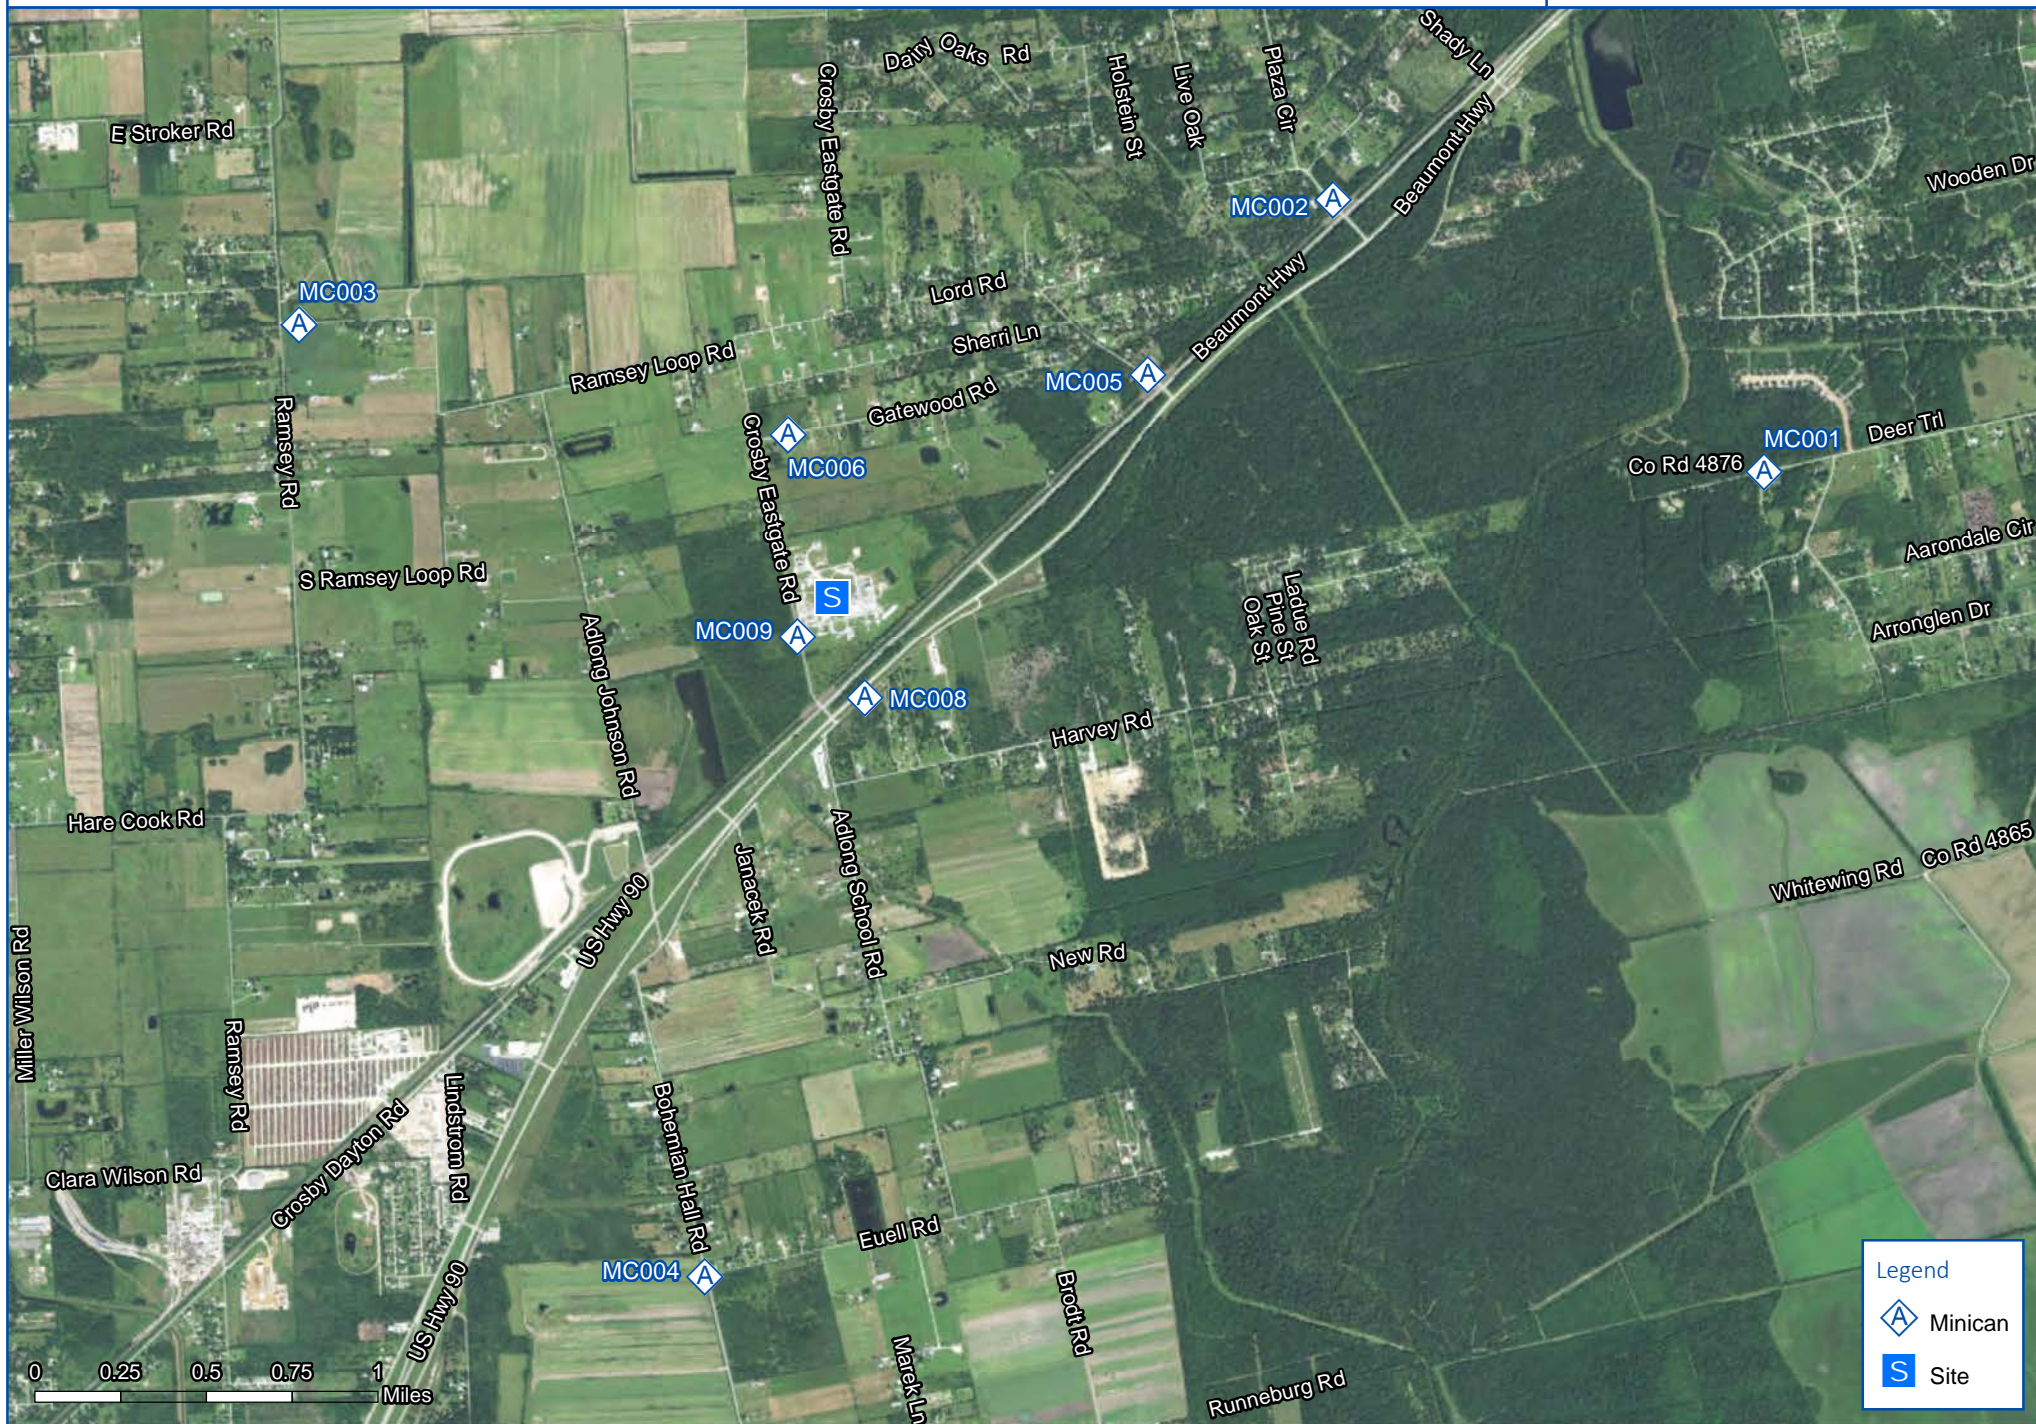
## **Map of Analytical Air Sampling Locations**

To supplement real-time air monitoring, CTEH® deployed areas along the perimeter of the evacuated area within the community. Evacuated canister (Minican™) samplers were regulated to collect air evenly over a 24-hr period. Analytical air samples will be submitted to SGS Galson Laboratories, an AIHA-accredited laboratory, for analysis using EPA Method TO-15. A map highlighting the analytical air sampling locations is provided as **Attachment C**. Analytical Air Sampling Results will be reported upon receipt from the laboratory.

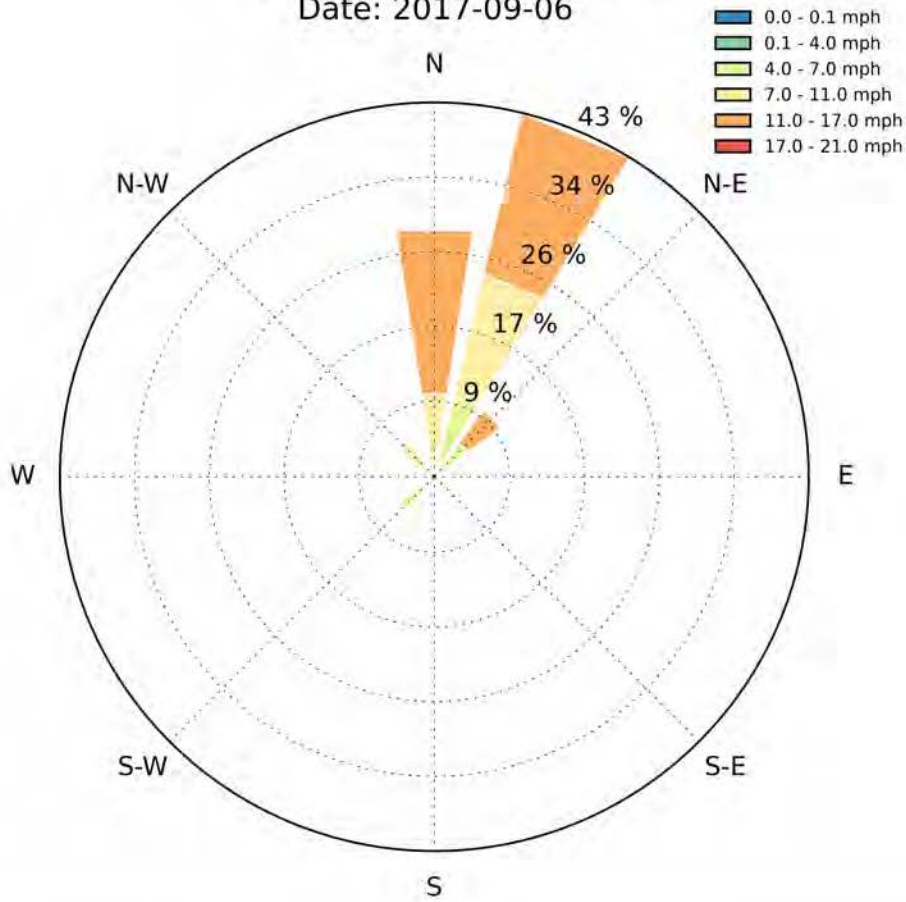
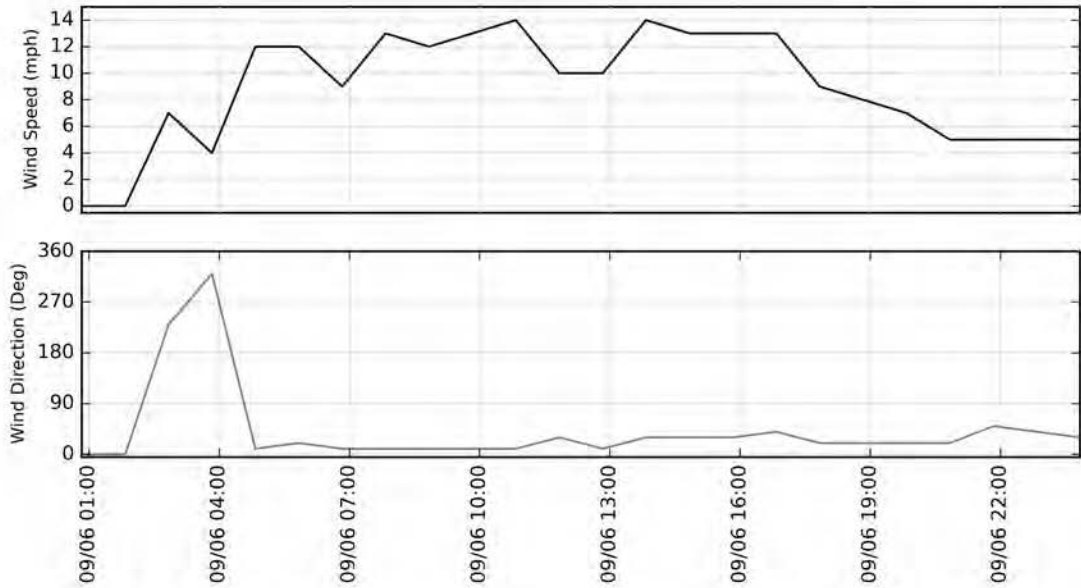
Weather Station: KHPY  
Date: 2017-09-06

## **KHPY Windrose**

**(Highland Park Airport - 12.5 miles SSE of Site)**
